PRE-DEMOLITION ENVIRONMENTAL ASSESSMENT REPORT

SITE INVESTIGATED: New Jersey City University
251 West Side Avenue
Jersey City, NJ 07305

ASSESSMENT BY: Omega Environmental Services, Inc.
280 Huyler Street
South Hackensack, NJ 07606

DATE OF REPORT: October 20, 2017

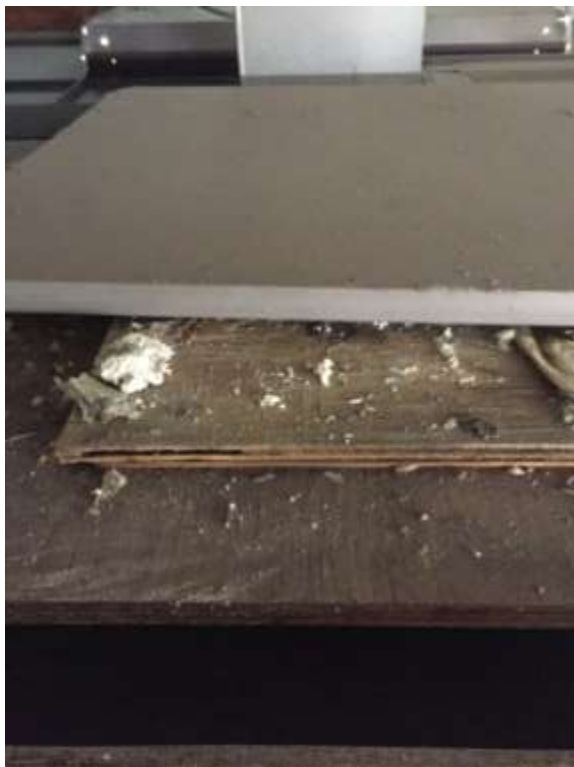
Debris above ceiling

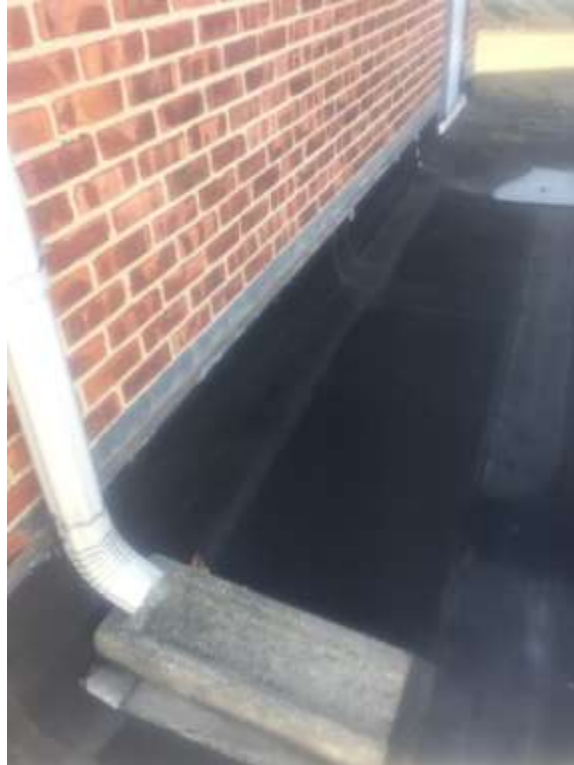
Flashing

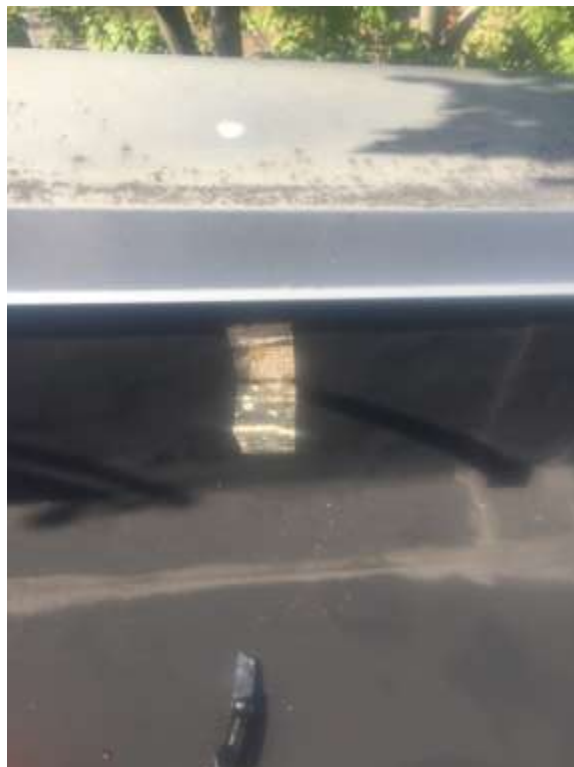
Parapet wall flashing

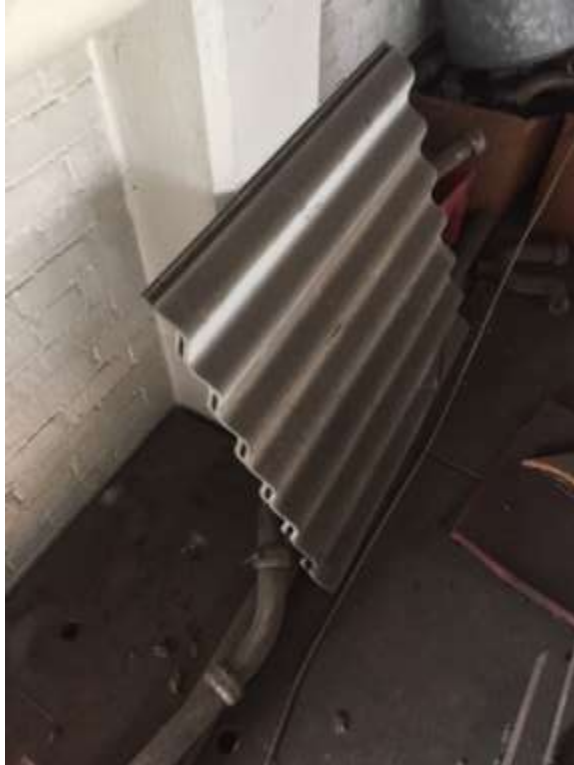
Transite panel

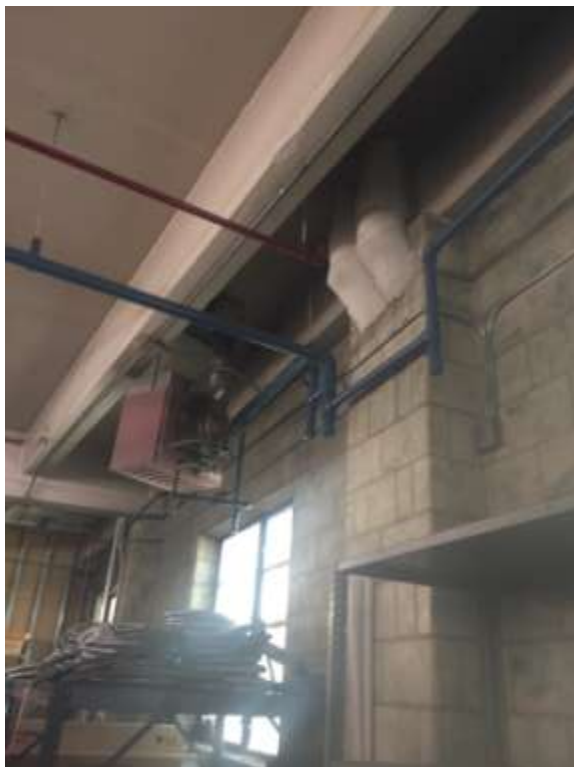
Transite pipes

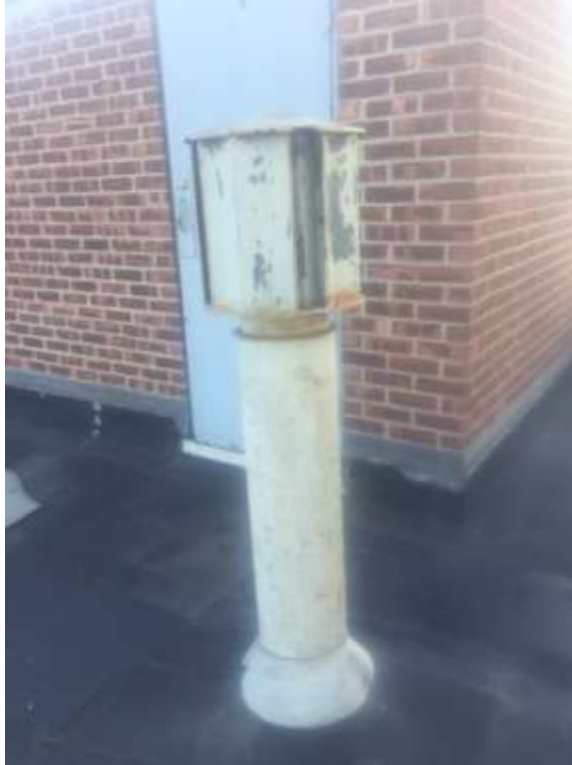
Transite vent

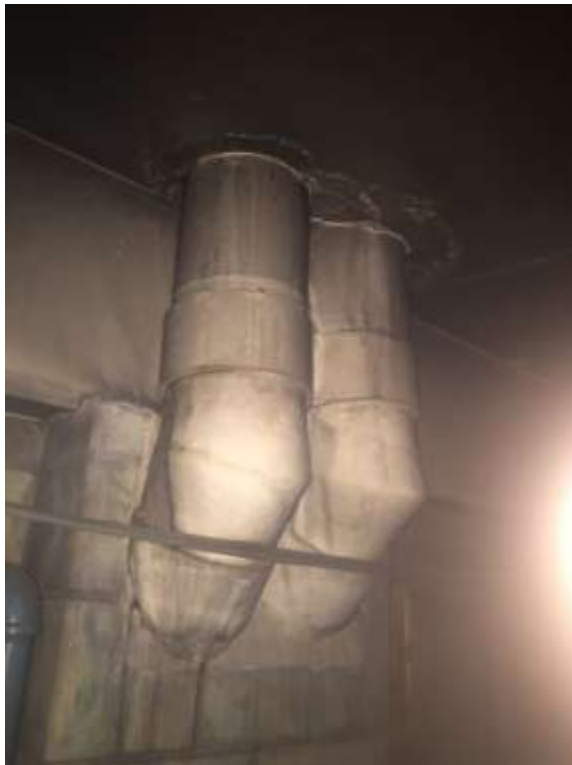
Transite

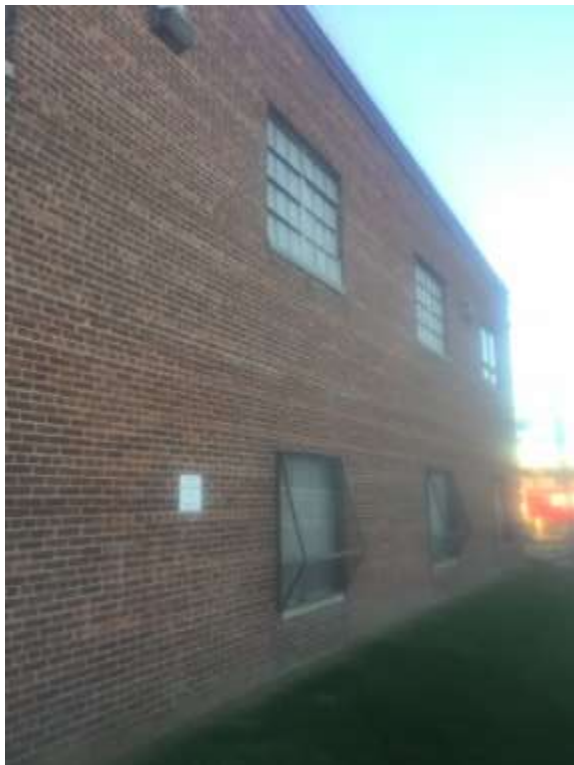
Window glazing
